**NASA TM X-1195**

**ANALYSIS OF AN EMERGENCY  
DECELERATION AND DESCENT OF THE  
XB-70-1 AIRPLANE DUE TO ENGINE DAMAGE  
RESULTING FROM STRUCTURAL FAILURE**

*by Chester H. Wolowicz*

*Flight Research Center  
Edwards, Calif.*

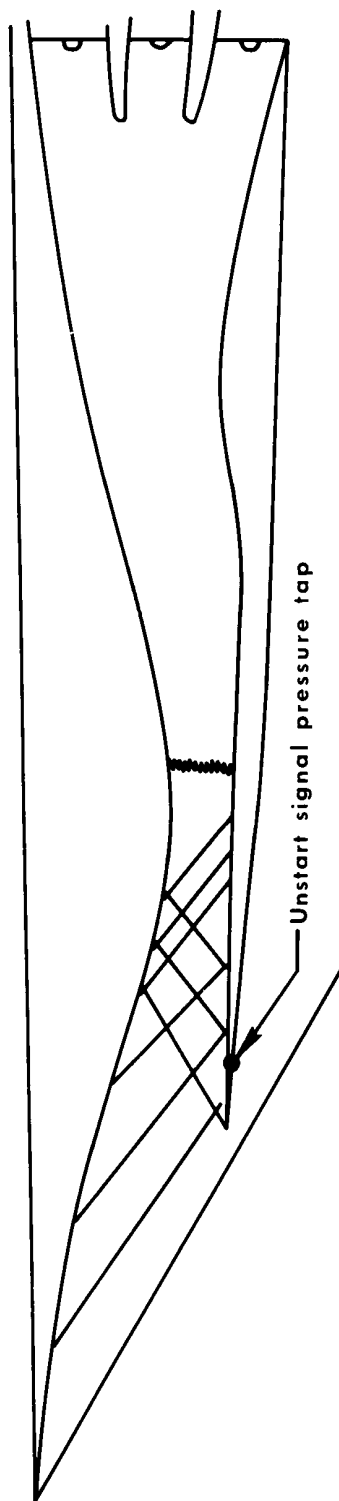
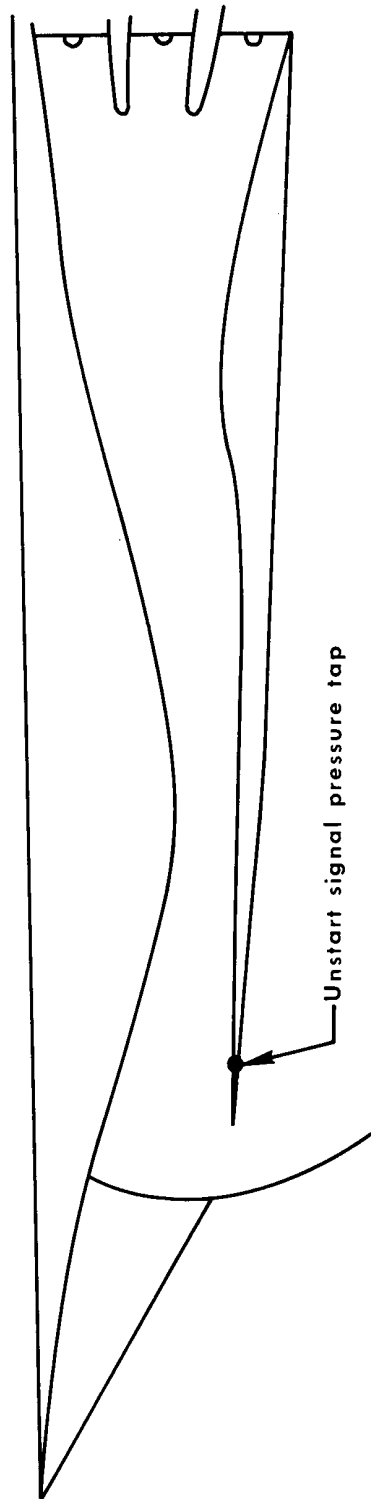
(b) Start and unstart positions of normal shock.

As stated previously, the intake-air bypass doors in each of the two ducts are used in conjunction with the controlled width of the two-dimensional throats to control the position of the normal shock in each of the ducts (fig. 2). The throat is normally at maximum opening below  $M = 1.7$ , and the bypass doors are normally closed below  $M = 1.0$ . Both the throat and the bypass doors have, respectively, schedules of width and opening as shown in figure 2(a) to provide optimum inlet operation. Below  $M = 2.0$ , the inlet ducts operate in the unstarted condition. Incorrect scheduling of the throat width and the bypass opening can result in engine stall at any Mach number, buzz above  $M = 1.5$ , and unstart conditions above  $M = 2.0$ .

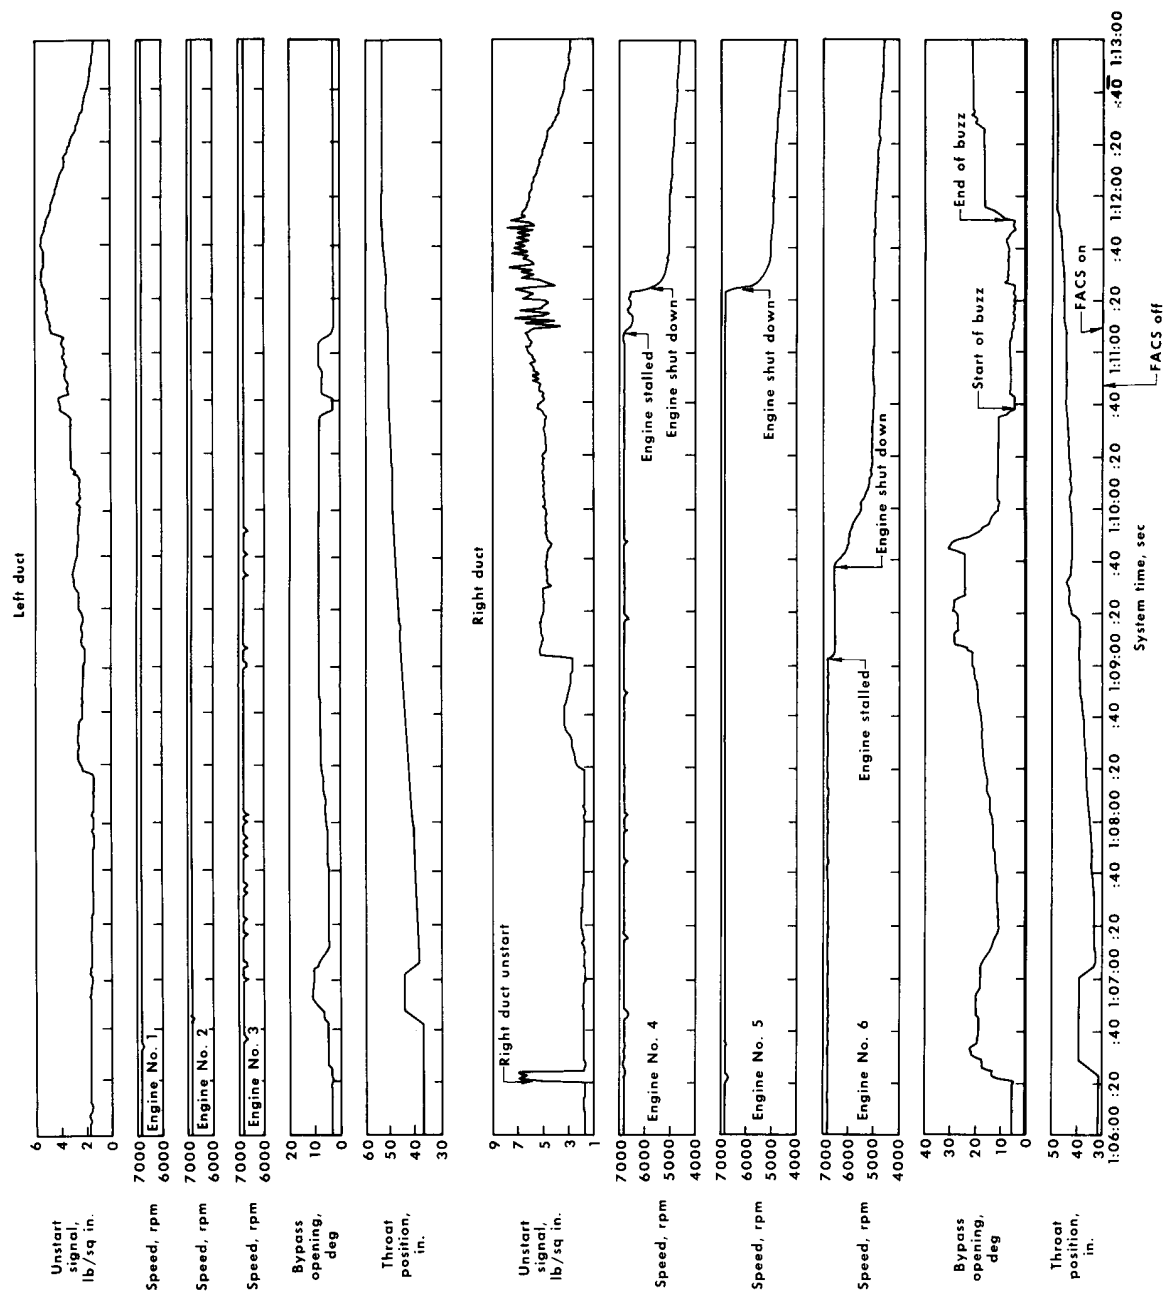
Figure 6. -- Time history of propulsion-system performance. XB-70-1; flight 12.

Initial indication of wing-apex failure and its ingestion into the right duct at the time the aircraft was flying at  $M = 2.6$  at 63,000 feet pressure altitude was evidenced by a local Mach disturbance at the duct and was also reflected in the shock-position pressure ratio. The copilot, observing the disturbance to the normal shock position in the right duct as noted on the shock-position indicator, but unaware of its cause, proceeded through normal corrective action to open the right-duct bypass doors to reposition the shock. At this time, on the basis of the pattern of damage done to the duct and its engines, a portion of the disintegrated apex struck engine No. 5, causing a momentary stall and a pronounced unstart signal from the right duct--as evidenced in figure 6 at time 1:06:21. The left duct shows normal operation at this time. The copilot apparently reacted to the unstart signal, to regain a started inlet condition, by continuing to open the bypass doors in the right duct. Less than a second later, he switched the throat to manual mode, which caused the throat to open and the inlet to start, since the manual control had been prepositioned to the restart position. The actions caused the normal shock to return to its throat position (start condition). Transverse resonant fuselage vibrations which were initiated by the unstart pulse (fig. 7(a)) damped out.

After succeeding in returning the shock to its started position, the pilot closed the right bypass doors toward their original position (fig. 6) and returned the throat control to AUTO mode; however, because of the damage to the engines and the consequent reduction in the engine airflow, it became necessary to set the doors to  $11^\circ$ , rather than the original  $4^\circ$ , to bring the shock to its proper operating position. The subsequent opening of the right bypass doors from  $11^\circ$  to  $21^\circ$  to keep the normal shock in proper position was, to a large extent, dictated by the gradual deterioration in airflow through the damaged engines as well as a deceleration from  $M = 2.5$  to 2.2 in the time interval 1:07:20 to 1:09:03. (Within this interval, engine No. 5 was throttled to military power because of persistent vibration; all other engines were cut to minimum afterburner and began to show minimum afterburner instability. The minimum afterburner instability is not related to the problem generated by the damage to the engines. This instability is a problem related to the engines installed in the XB-70 and has been encountered numerous times. At time 1:08:16 to 1:08:20, because of the persistence of the instability (not illustrated in fig. 6), all engines except No. 5 were momentarily advanced in power and then retarded to military power for deceleration and descent to terminate the flight.)

throat. Because of the deteriorated condition of the damaged engines and the consequent reduced airflow conditions, as well as the reduction of aircraft speed, this bypass angle did not provide sufficient opening to restart the inlet. At  $M = 2.17$  (time 1:09:18) the unstart signal light went out, possibly leading the copilot to believe that the right-duct inlet had started. However, the light went out because of an automatic disarming of this warning system at  $M = 2.17$ , even though inlet start conditions prevail down to  $M = 2.0$ , as shown in figure 2(a). Inability to recover engine No. 6 from the stalled condition subsequently resulted in it being shut down at time 1:09:38 at  $M = 2.08$ . This was followed by a closing of the right bypass doors to  $11^\circ$ .

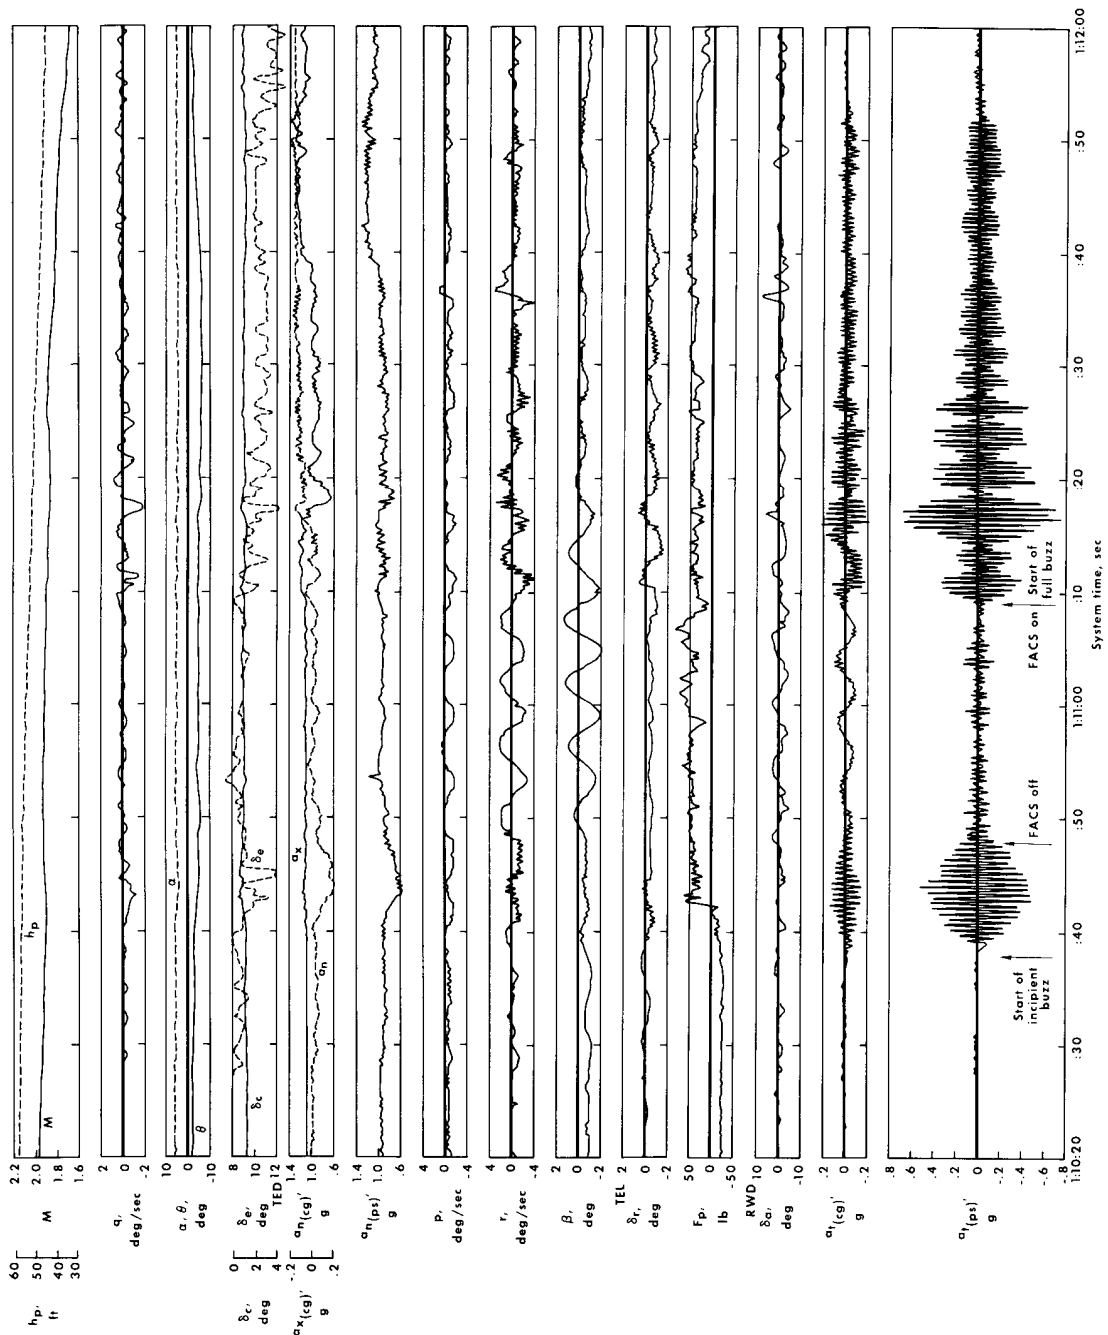
(b) System time = 1:10:20 to 1:12:00.

1:11:36-37	Engines on left side were increased in power and left rudder was applied to balance the asymmetric thrust.	M = 1.81.
1:11:45	Right-duct bypass doors closed from 7° to 5°.	Transverse oscillation persisting within beat frequency.

1:11:52	Right-duct bypass doors opened rapidly from 5° to 16 1/2°.	M = 1.75. Buzz and resonant oscillations ceased immediately and did not recur for the remainder of the flight.

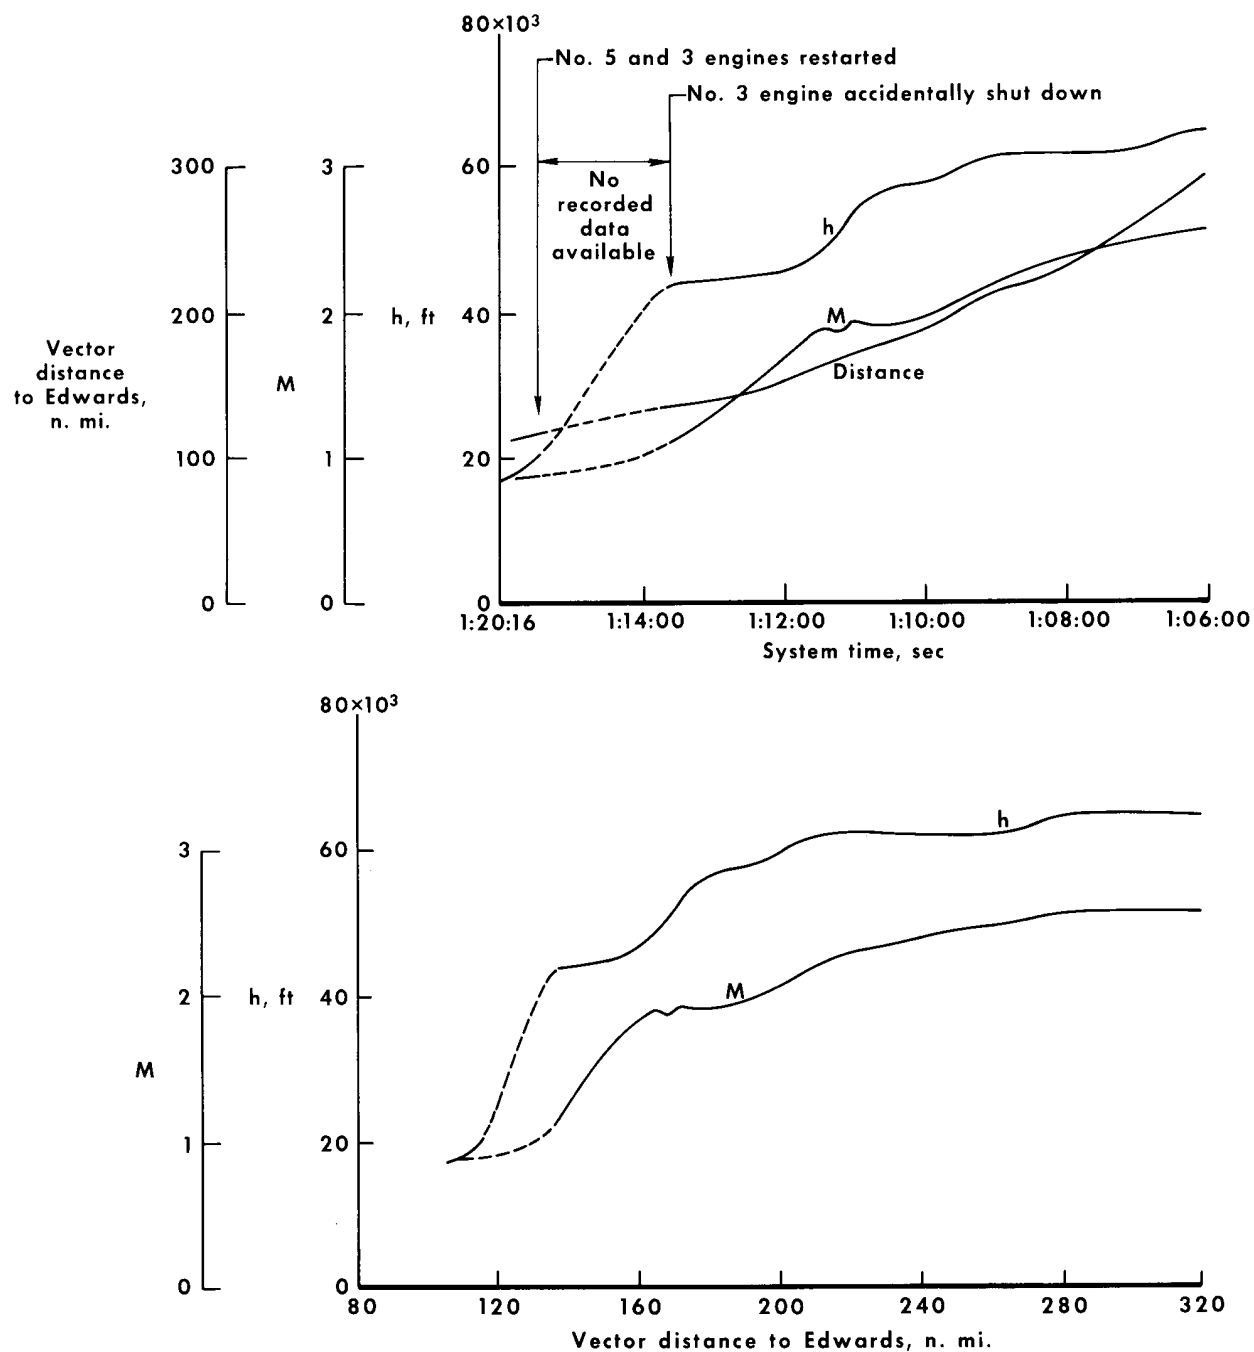
Figure 9.— Time and distance histories of altitude and Mach number for emergency portion of flight. Data based on NASA radar.

Slight discrepancies in the time history of the pressure altitude in figure 7 exist in comparison with the altitude time history shown in figure 9, obtained from NASA radar data. The discrepancy is not considered important for the purposes of this analysis.
